Compliant Foil Seal Investigations

Margaret Proctor

2003 NASA Seal/Secondary Air System Workshop

November 5-6, 2003

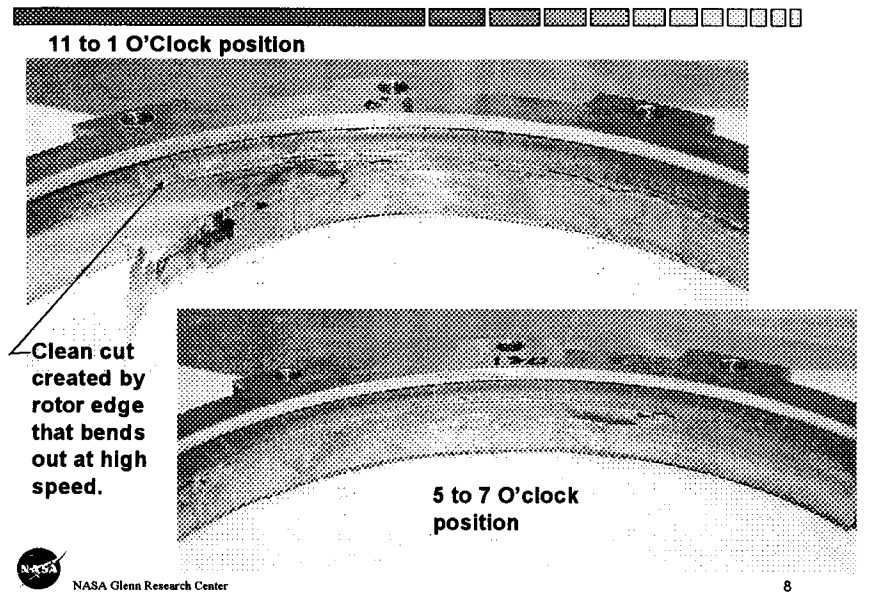
Damaged 8.5 inch Foil Seal

This is the 8.5 inch foil seal after room temperature testing to 30,000 rpm. The seal is damaged beyond use. Parts of the top foils and bump foils were found blown behind the rotor at disassembly. The Korolon coating is rubbed off and the top foil was burned through at places. Note the clean cut at the bend in the top foil. This cut aligns with the edge of the test rotor. The test rotor has an I-beam cross section at the rim. Hence at high speeds the edges of the rotor rim bend out radially farther than the axial center of the rim. This displacement combined with the chamfer on the edge of the rotor makes a nice cutting tool.

- The damage to the seal was likely caused by a loss of clearance due to centrifugal growth of the rotor and fatigue failure of the coating, which initiated a thermal runaway condition.

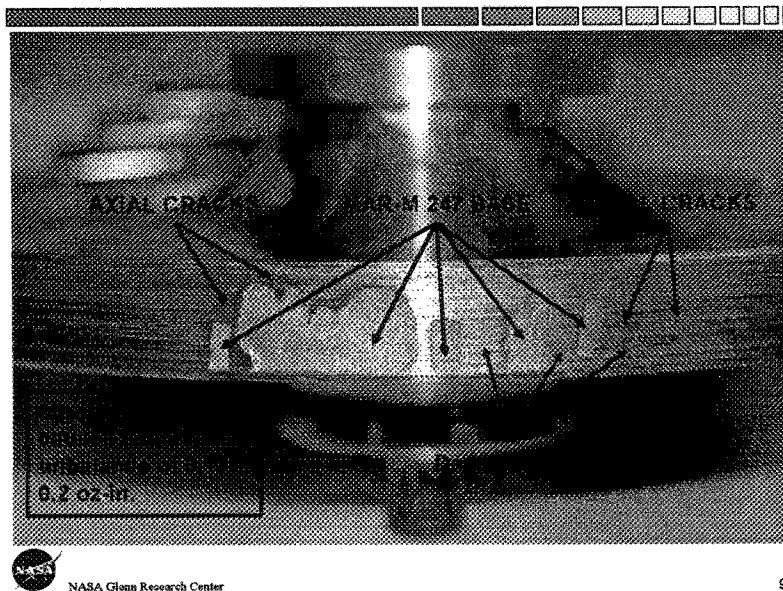
Damaged Rotor Coating

The rotor coating failed. The Mar M-247 rotor had a 0.010 inch thick CrC coating applied by high velocity oxygen fuel thermal spraying. By measuring the areas of the missing coating and the depth of the damage, the unbalance of the missing material is estimated to be 0.13-0.2 oz-in, which is 27-40 times greater than the balance specification for the rotor. Some hairline axial cracks are visible.

- Rotor coating selection and application needs a redesign.
- A good understanding of the seal operating environment and operating limits is paramount to success.

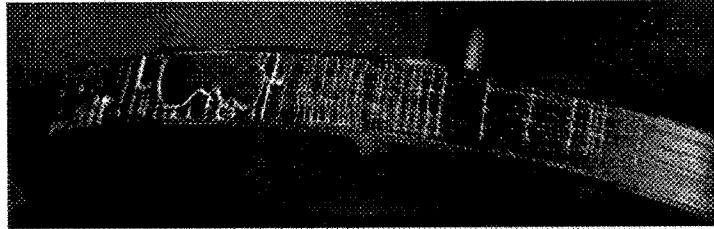
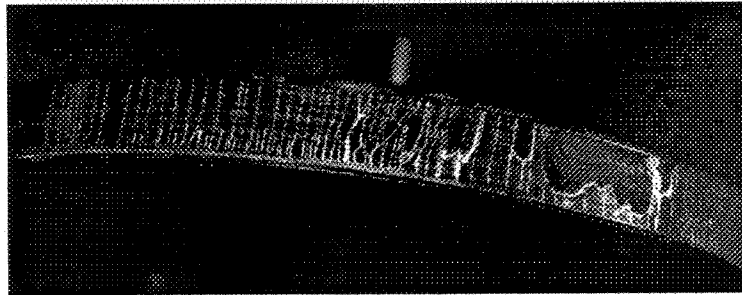
Rotor under flourescent penetrant dye inspection

Axial cracks, typical of heat checking, indicate fatigue failure of the coating.

Many axial cracks are visible in the rotor coating under flourescent penetrant dye inspection. These axial cracks are typical of heat checking and indicate fatigue failure of the coating. The fatigue failure is likely due to the mismatch in coefficients of thermal expansion for the rotor material Mar M-247 and the CrC coating.

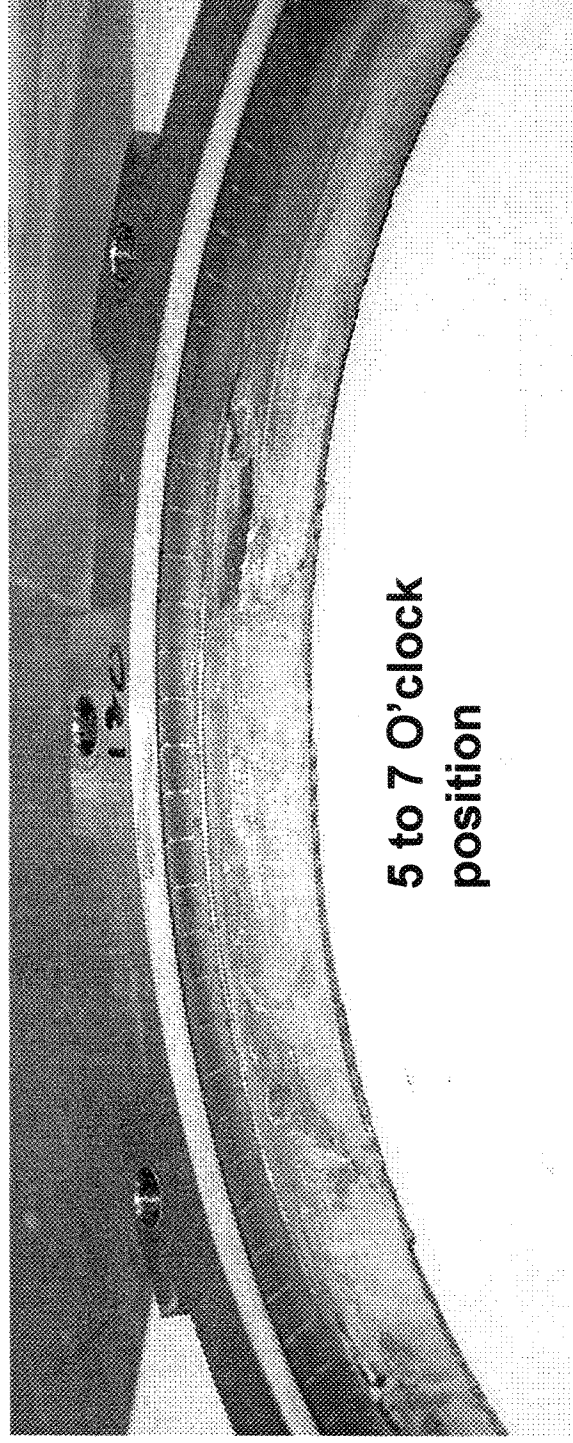
5 to 7 O'clock
position

Clean cut
created by
rotor edge
that bends
out at high
speed.

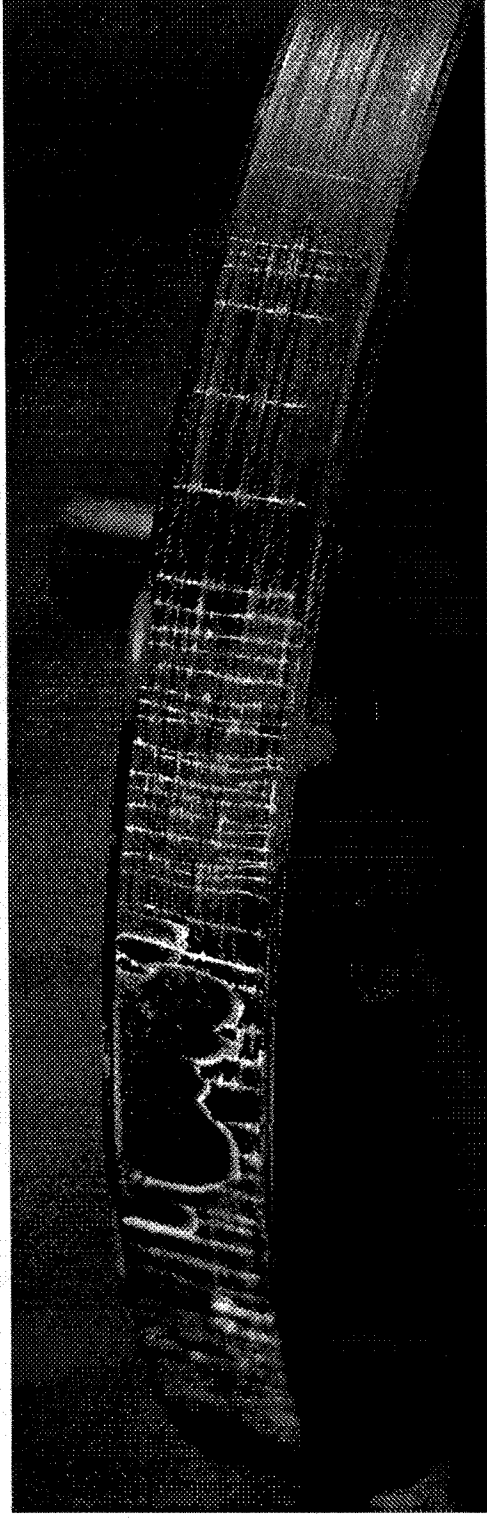
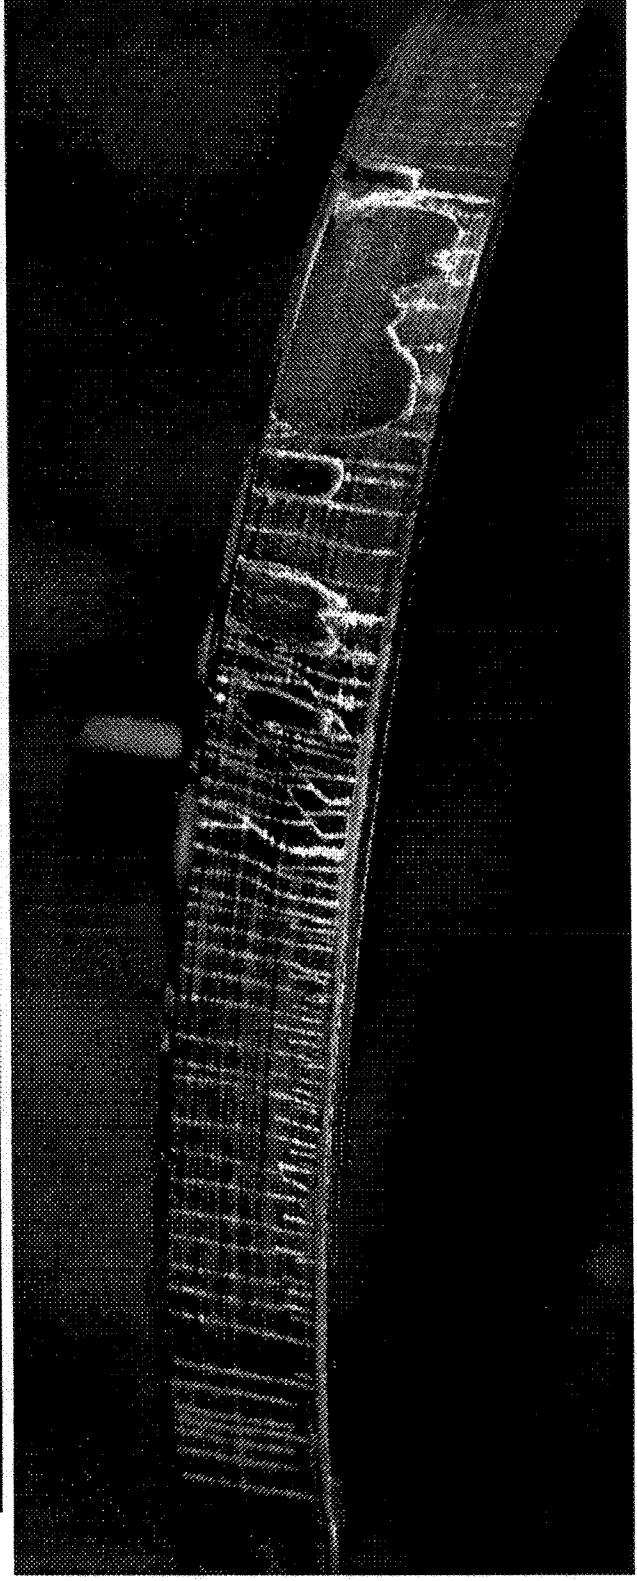
Rotor under flourescent penetrant dye inspection

Axial cracks, typical of heat checking, indicate fatigue failure of the coating.
